Bondlines – Online blade measurements (October 2012 and January 2013)

Department of Wind Energy E Report 2013

DTU Wind Energy E-0036

The BONDLINEs project (EUDP File Number 64012-0128) is subtitled “Regain the operational life time of installed WTG blades with structural defects”. The Objective is to develop, prepare for market and demonstrate an applicable method for regaining operational life of installed wind turbine blades with structural defects based on patented technologies (Bladena) for limiting deformations in panels. In the project this method will be demonstrated on a turbine in operation. The solution will remove the root cause for bond line defects, which are the dominant defect on blades.

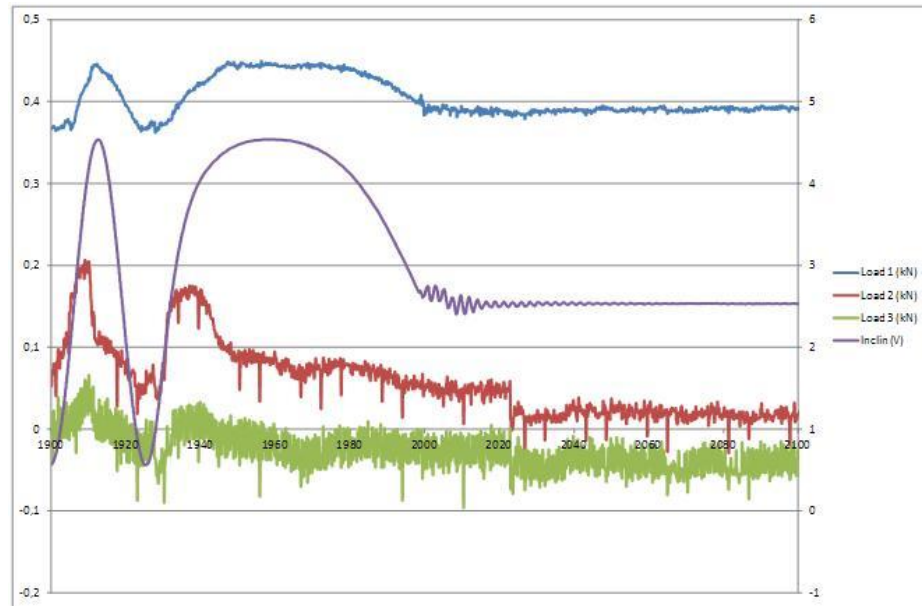
Fig. 32 - Detail of the output from Test 1 showing the turbine deceleration and stop at blade position 0°

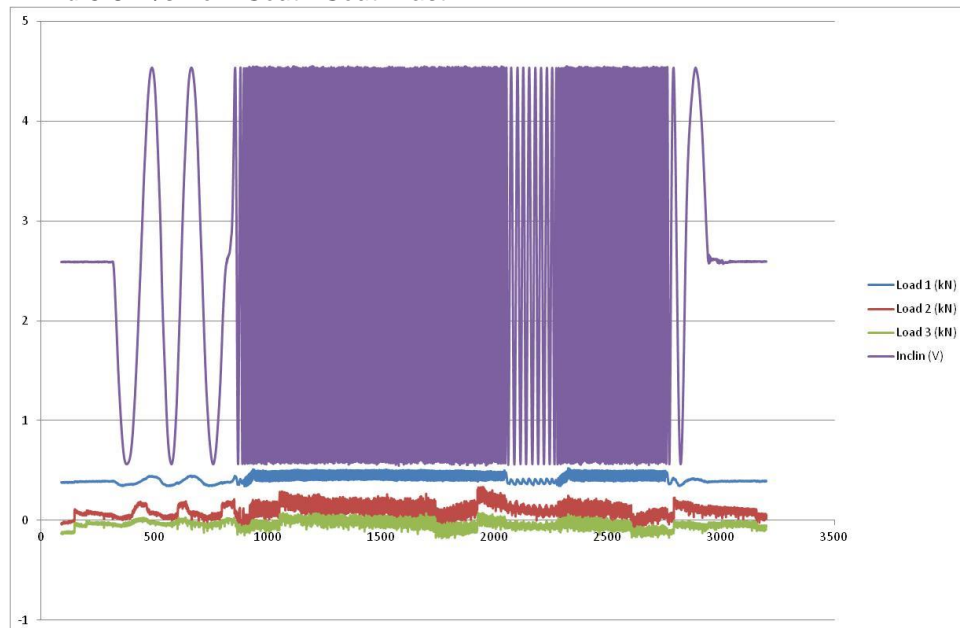
Fig. 33 Full trace for Test 2 (23/oct)

The overview trace for Test 2 shows the data acquisition starts with Blade A pointing down (position 0°). At around 300s the blade begins to rotate in idle condition (around 82-84 deg pitch). Around 850s the blade enters autorun operation (close to 0 deg pitch). Around 2050s the turbine automatically changes to blade pitch 30 deg due to very low wind speeds. At 2275s the turbine changes the blade pitch back to being close to 0 deg again and normal operation resumes. At 2760s the turbine goes to idle again (around 82-84 deg pitch). At 2940s the turbine is halted with Blade A in position 0°.

Again it can be noted that the output from Load Washers 2 and 3 is “noisy”.

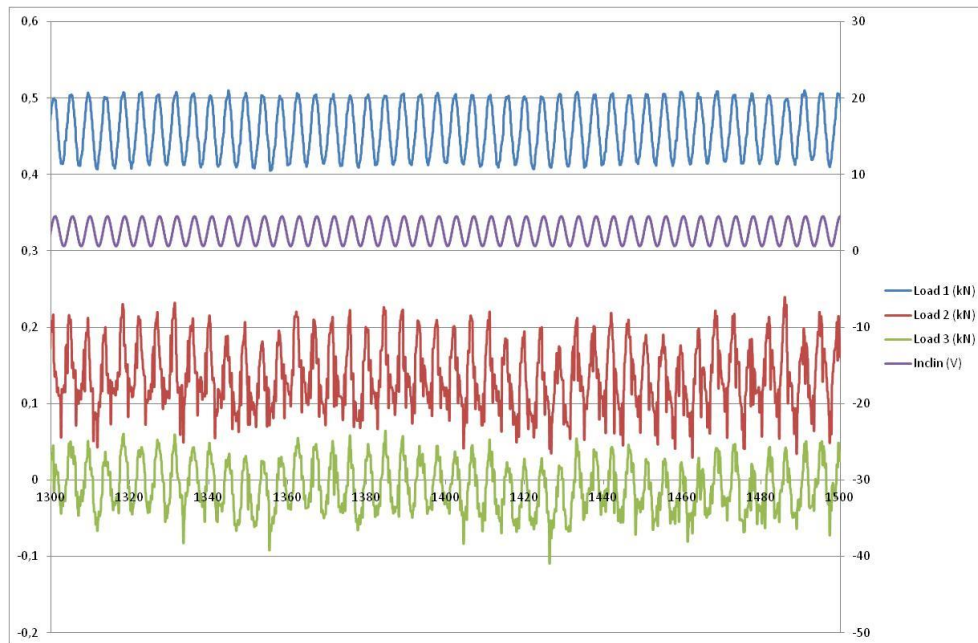
Fig. 34 - Detail from Test 2 showing the first autorun period

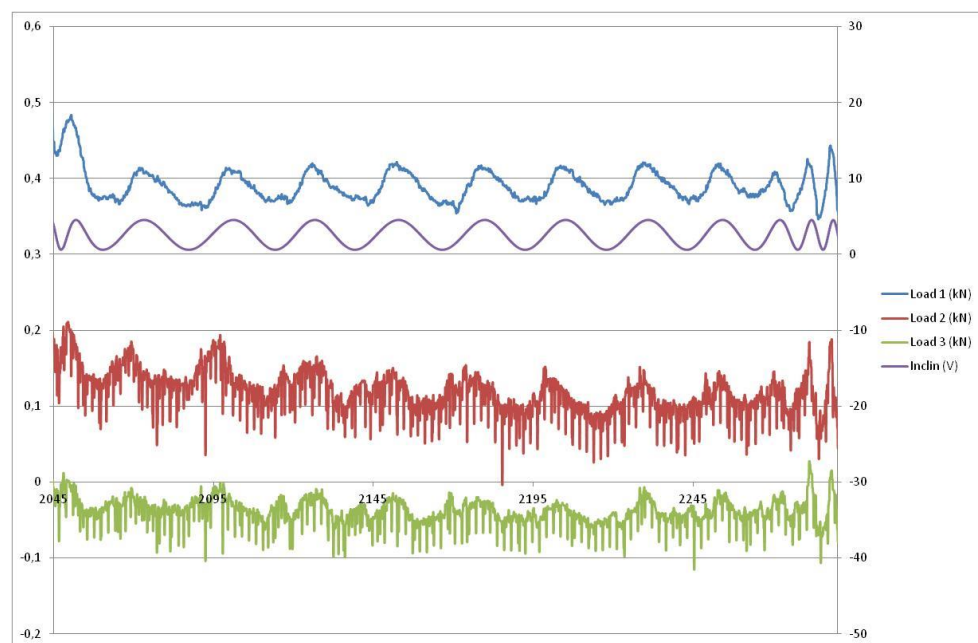
Fig. 35 - Detail from Test 2 showing the automatic change to 30° pitch during low wind conditions

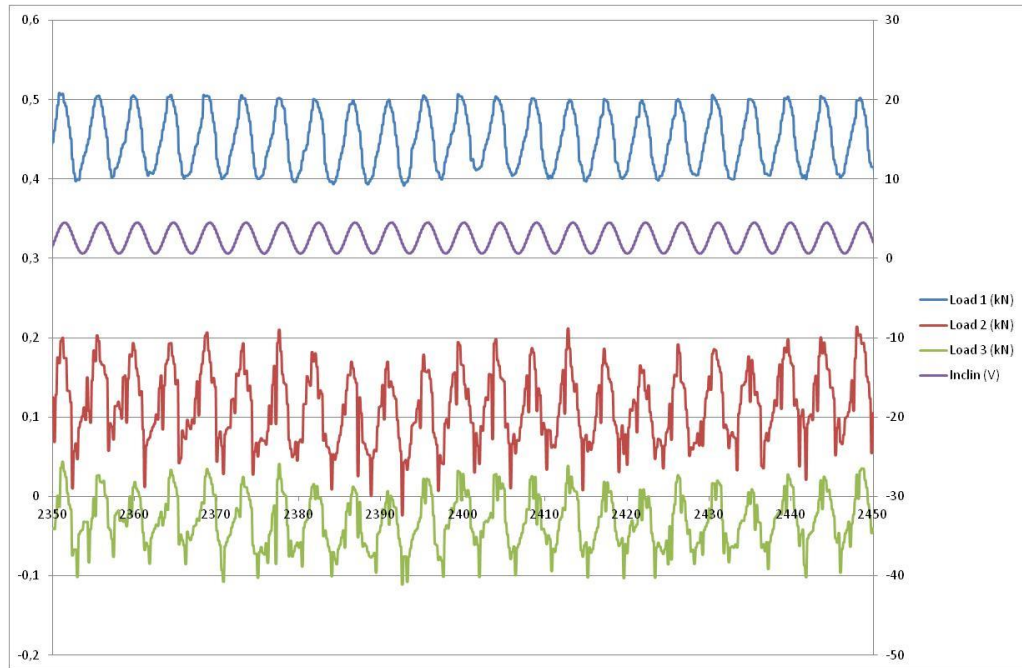
Fig. 36 - Detail from Test 2 showing the first autorun period

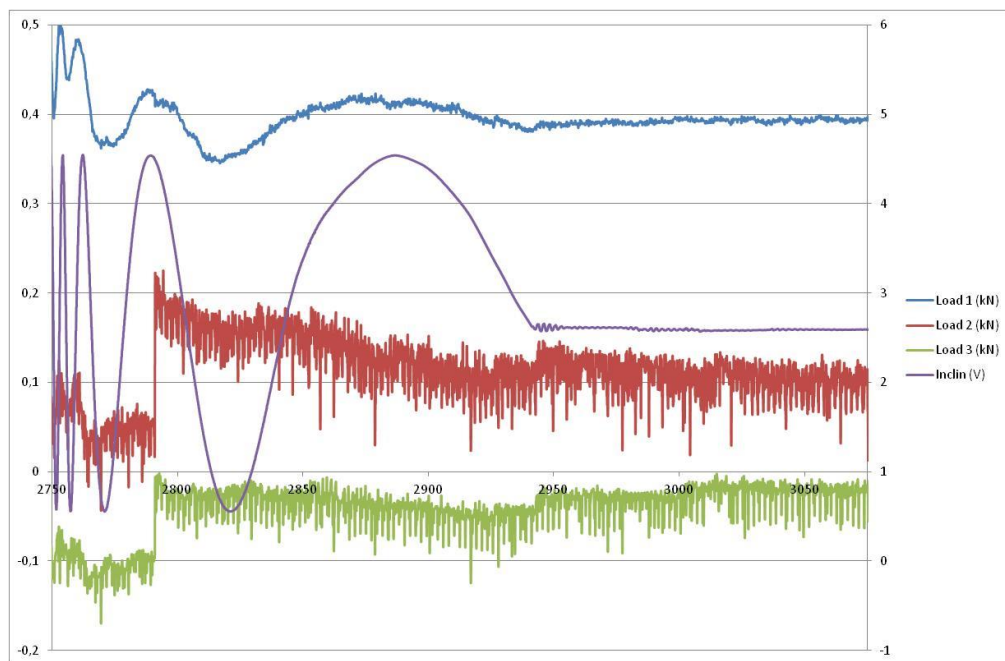
Fig. 37 - Detail of the output from Test2 showing the turbine deceleration and stop at blade position 0°

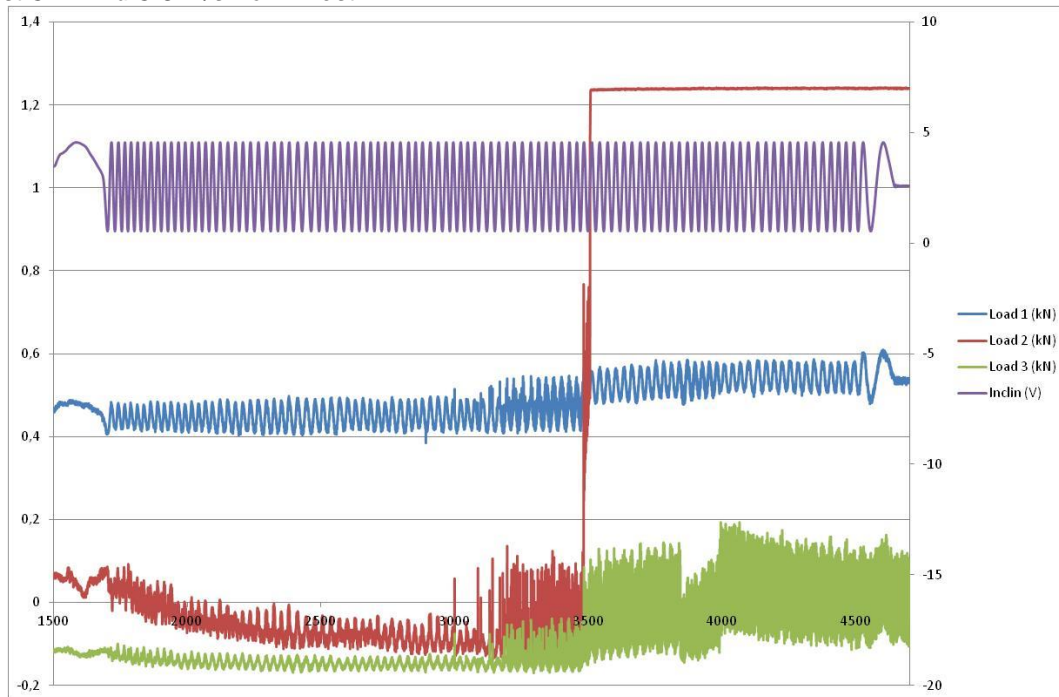
Fig. 38 Detail of the full operation period during Test 3 (24/oct)

At around 1650s following the start of data acquisition, the turbine enters autorun operation (with the blade close to 0 deg pitch). At around 3000s some event appears to occur that changes the response on all the load transducers. At about 3450s a sudden change is noted in the response of load washer 2, although load washers 1 and 3 are also affected. A noise is also heard by the Bondlines personnel. At 4500s the turbine is placed in idle condition (blade pitch around 82-84 deg).

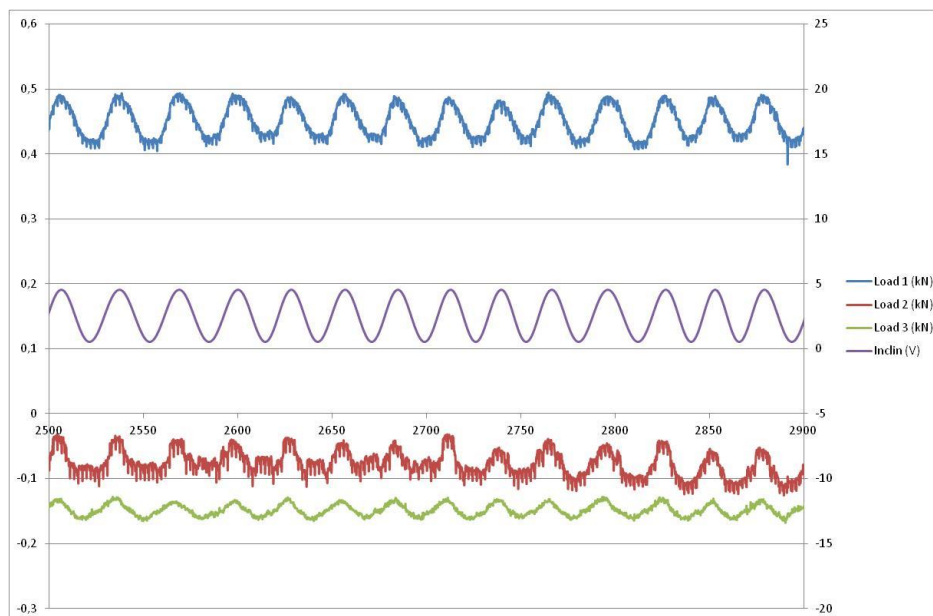
Fig. 39 - Detail from Test 3 showing output during the early stage of autorun condition

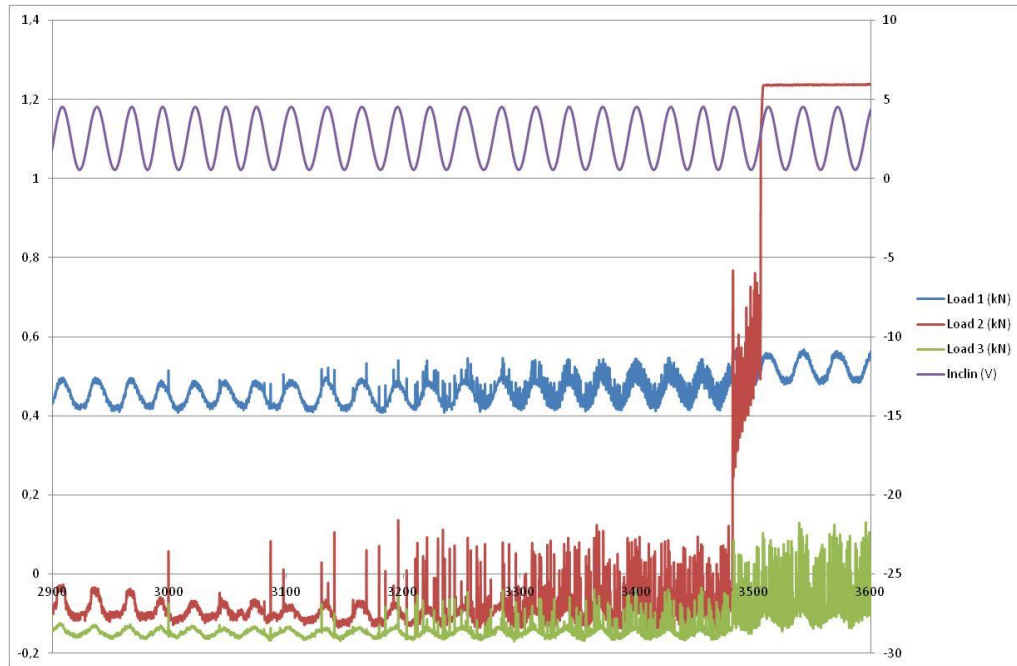
Fig. 40 - Detail from Test 3 showing the event on Load washer 2

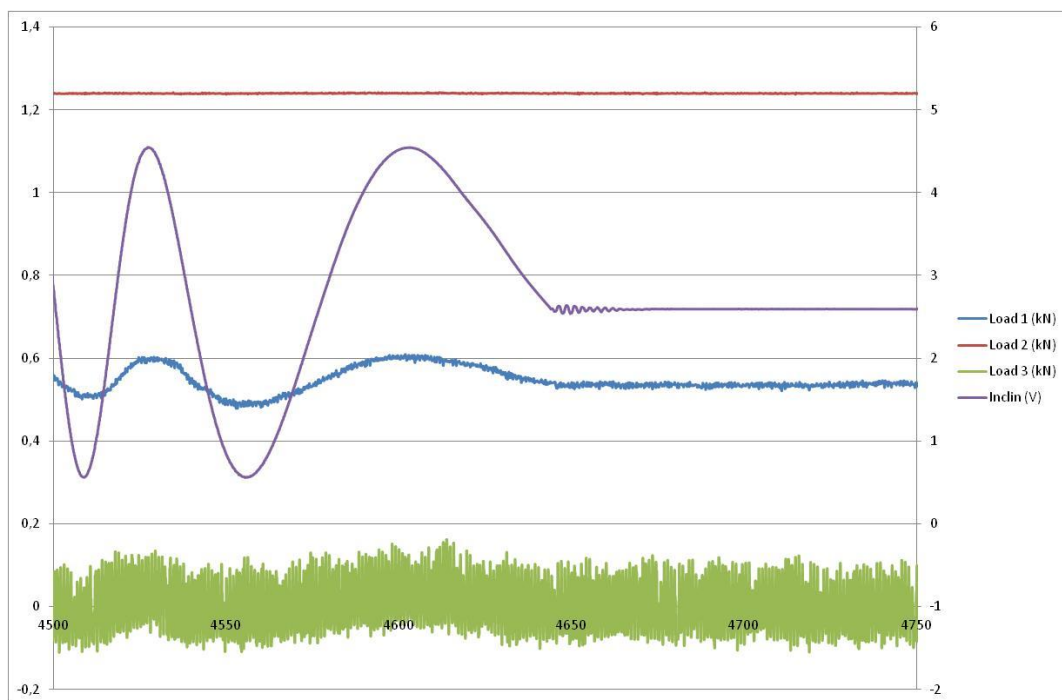
Fig. 41 - Detail from Test3 showing the turbine deceleration and stop at blade position 0°

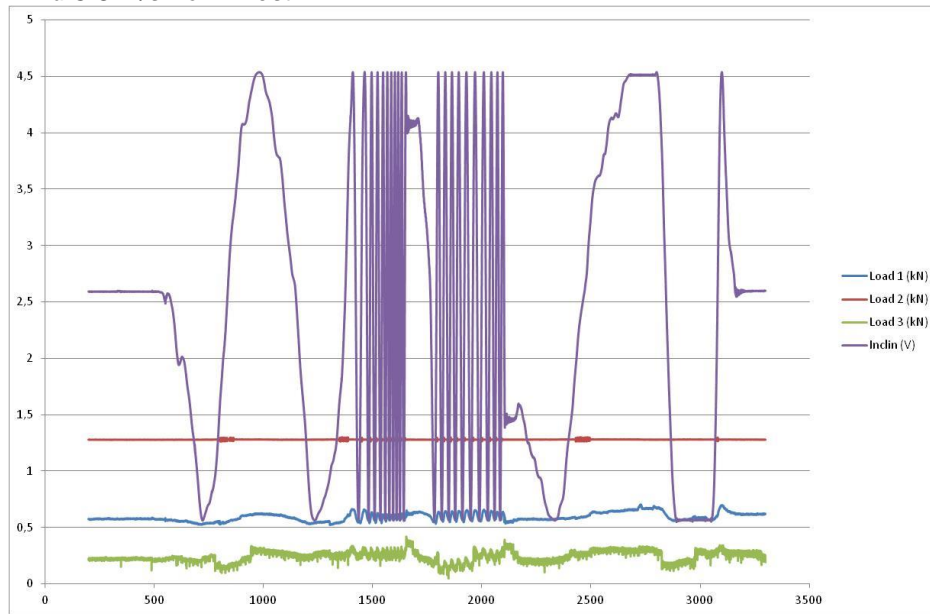
Fig. 42 - Full trace for Test 4 (24/Oct)

The overview trace for this measurement shows that data acquisition starts with Blade A pointing down (position 0°). At around 525s the blade begins to rotate in idle condition (around 82-84 deg pitch). Around 1400s the blade is placed at 30 deg pitch until 1650s when there is an emergency stop on the turbine. Around 1750s the blade is placed at 22 deg pitch until 2100s when there is another emergency stop on the turbine. At around 2175s the blade begins to rotate in idle condition (around 82-84 deg pitch) again. At 2650s the blade is halted in the 270° position and the pitch is cycled from 90 deg to 0 deg and then back again. At 2800s the blade is rotated round to the 90° position and the pitch is cycled from 90 deg to 0 deg and then back again. At 3050s the blade is rotated round to the 0° position and data acquisition is halted at 3300s.

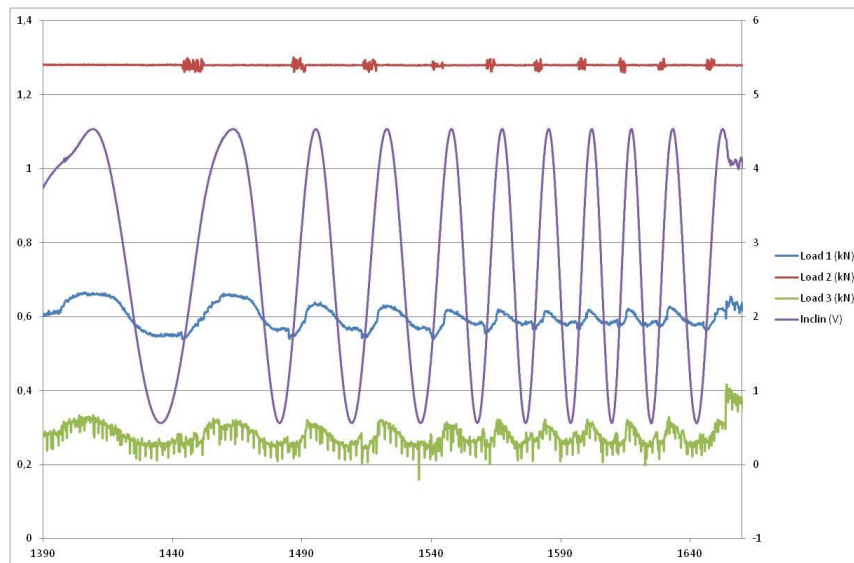
Fig. 43 - Detail from test 4 showing the blade going into operation at 30 deg pitch

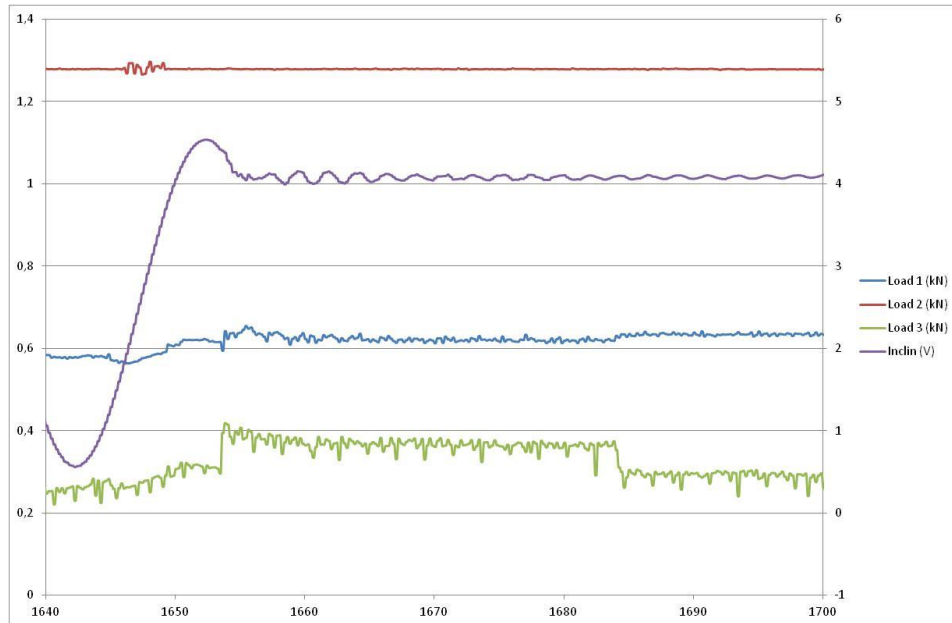
Fig. 44 - Detail from test 4 showing the blade doing an emergency stop whilst rotating at 30 deg pitch

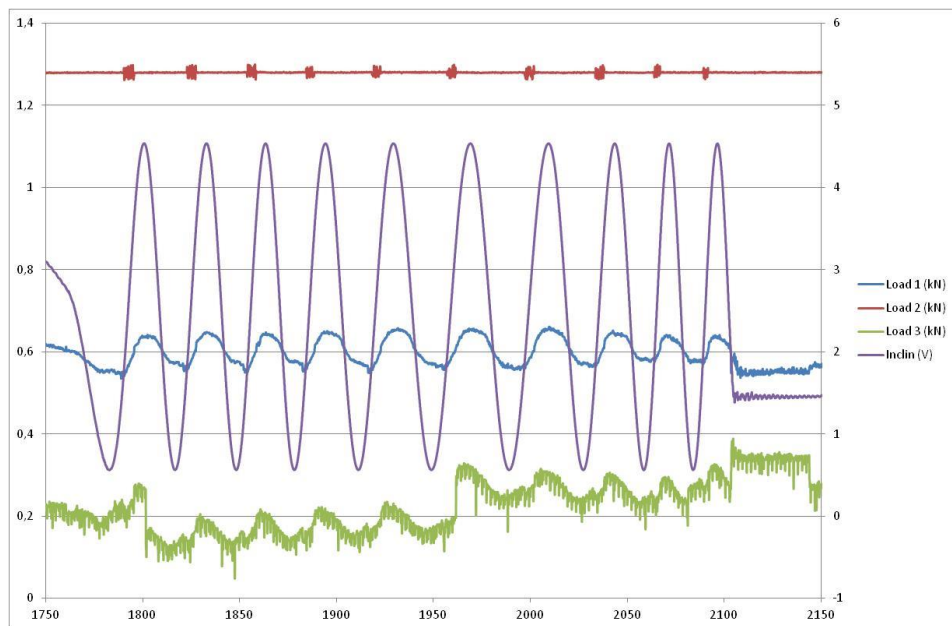
Fig. 45 - Detail from test 4 showing the blade going into operation at 22 deg pitch

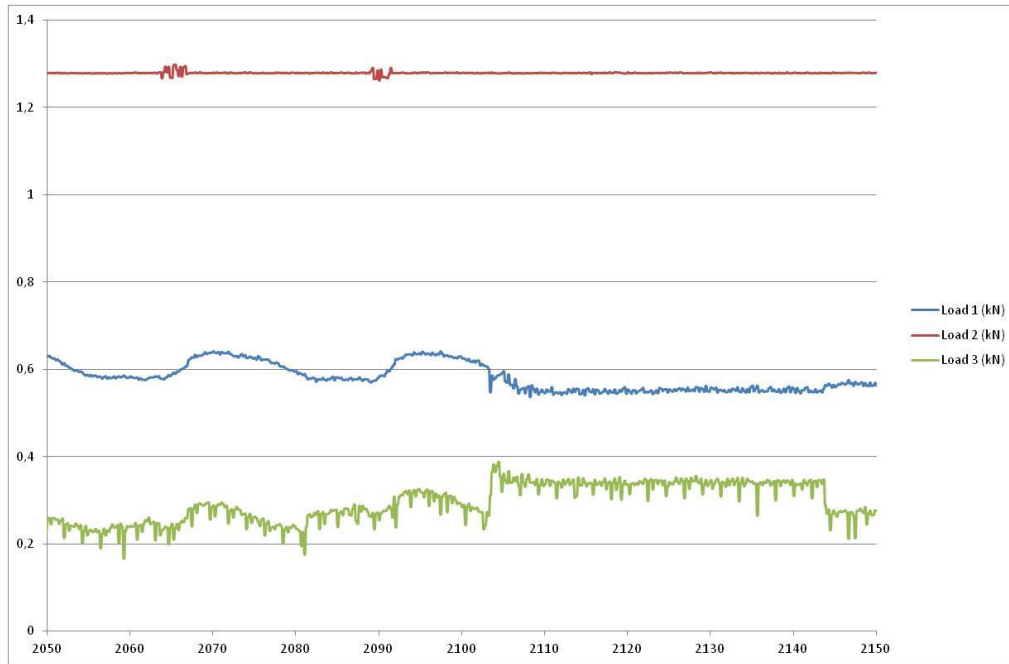
Fig. 46 - Detail from test 4 showing the blade doing an emergency stop whilst rotating at 22 deg pitch

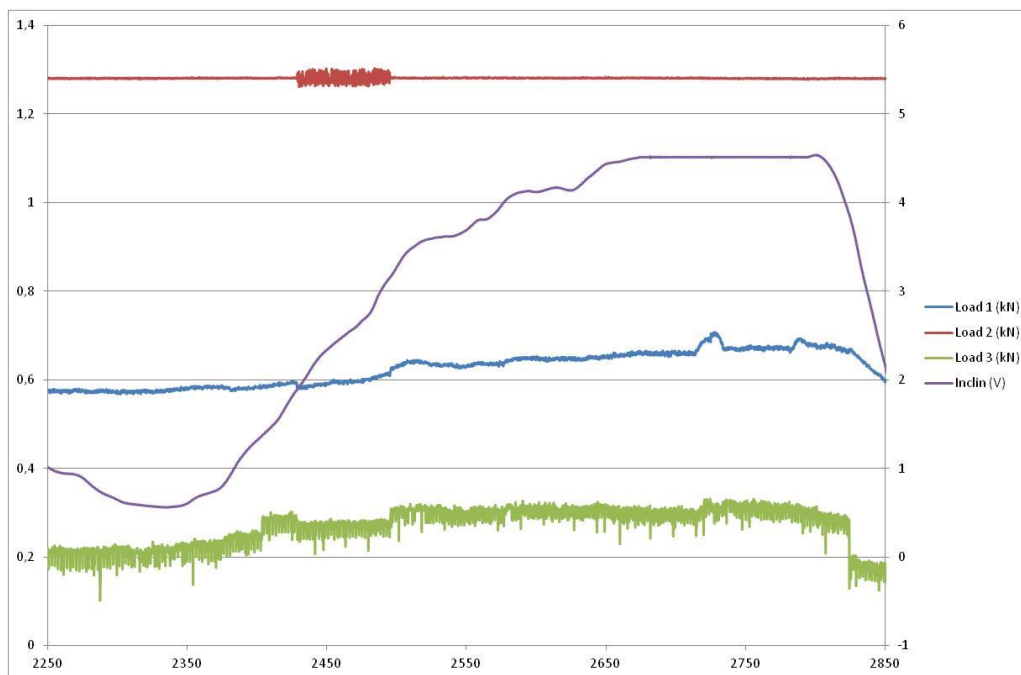
Fig. 47 - Detail from test 4 showing the blade at position 270° and changing blade pitch from 90 deg to 0 deg and then back again

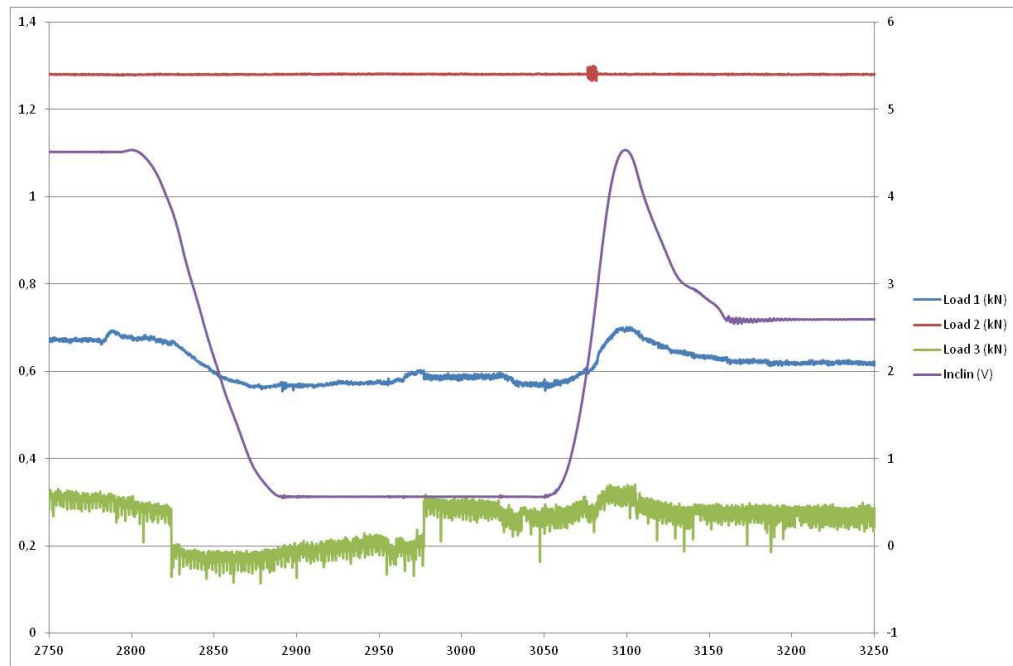
Fig. 48 - Detail from test 4 showing the blade at position 90° and changing blade pitch from 90 deg to 0 deg and then back again

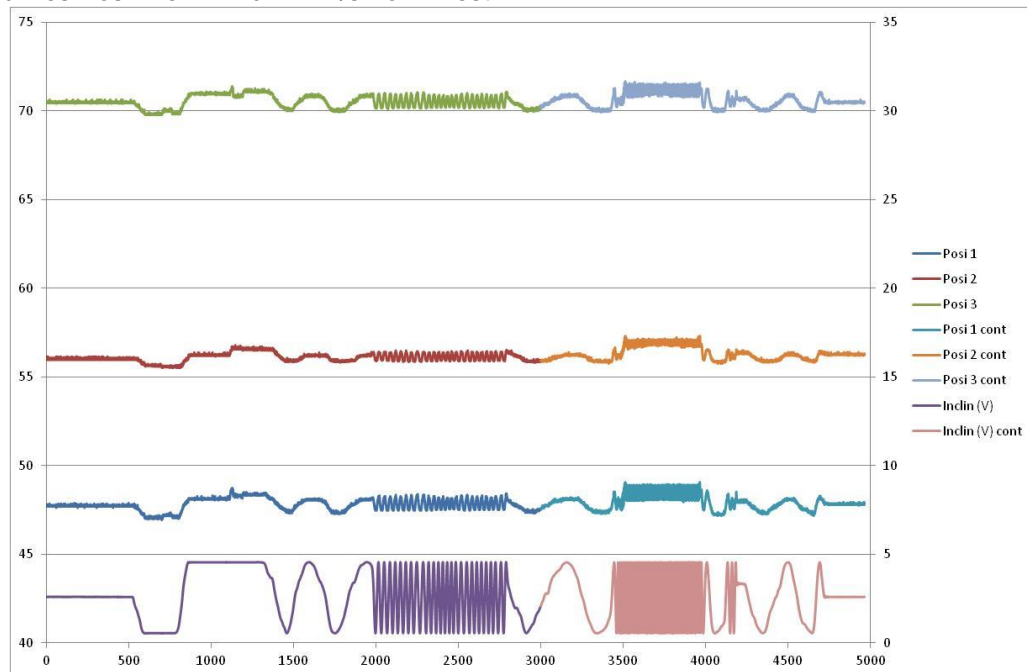
Fig. 49 - Full trace for posiwire measurement (24/oct)

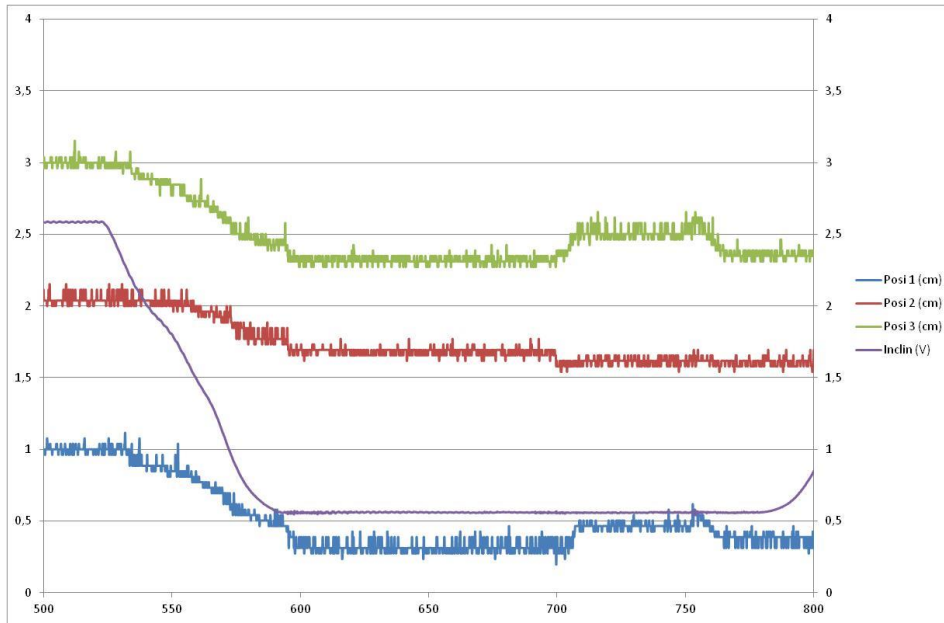
Fig. 50 - Detail from posiwire showing the blade rotating to the 90° position where the pitch is cycled from 90 deg to 0 deg and then back again

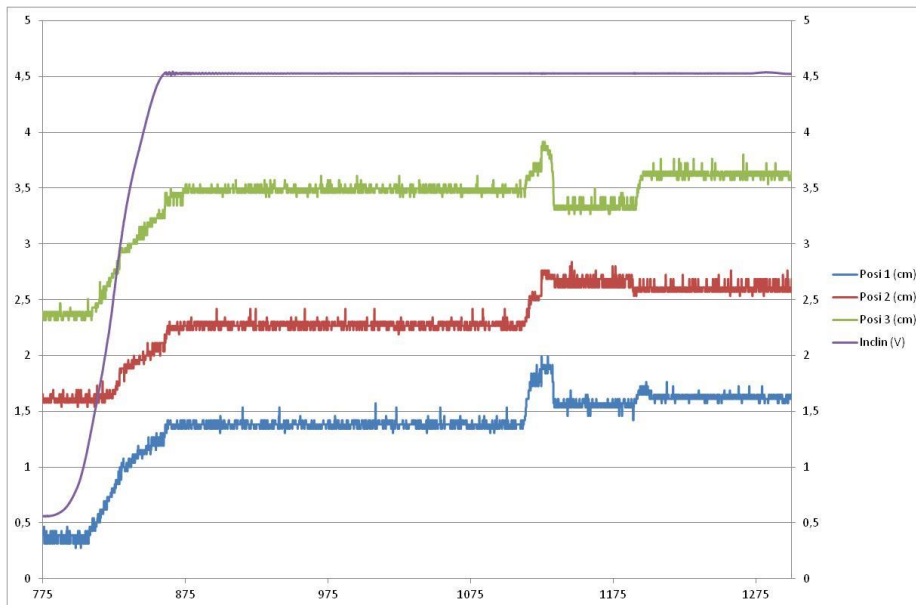
Fig. 51 - Detail from posiwire showing the blade rotating to the 270° position where the pitch is cycled from 90 deg to 0 deg and then back again

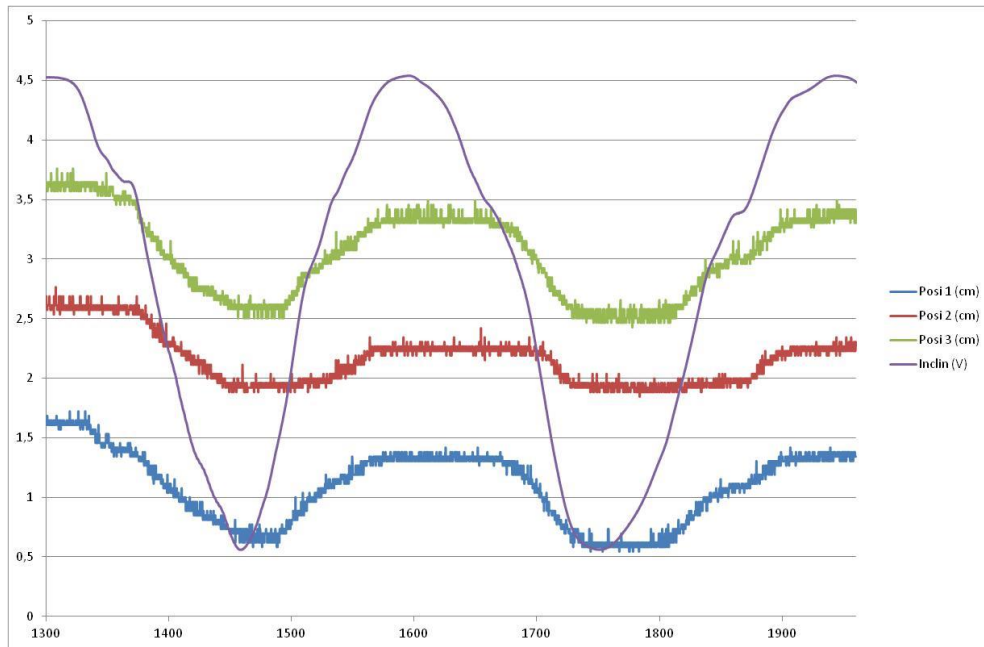
Fig. 52 - Detail from Posiwire showing the rotation while at blade pitch 85 deg

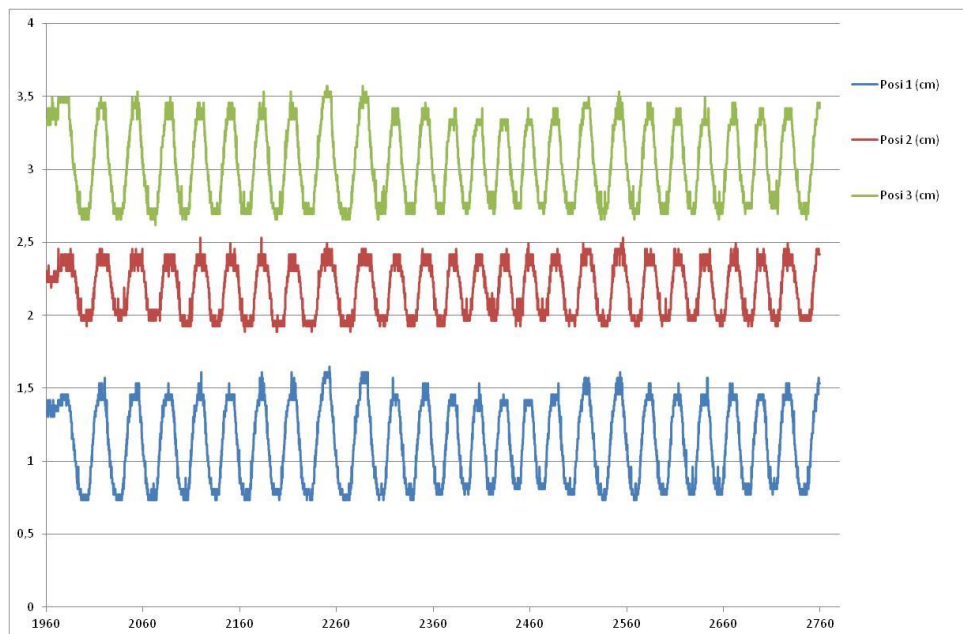
Fig. 53 - Detail from Posiwire showing the rotation while at blade pitch 45 deg

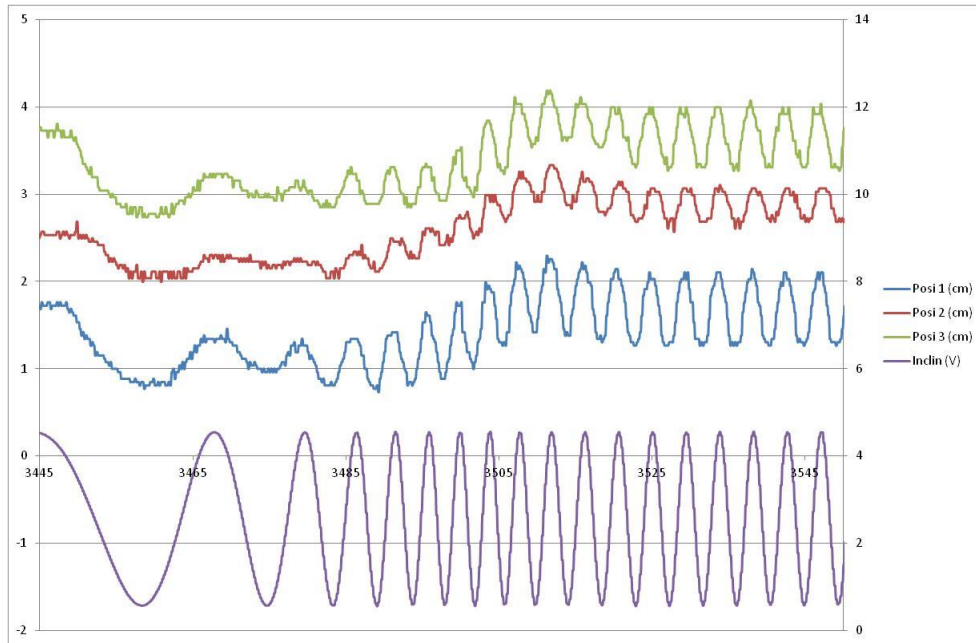
Fig. 54 - Detail from Posiwire showing the rotation while the blade accelerates at blade pitch 0 deg

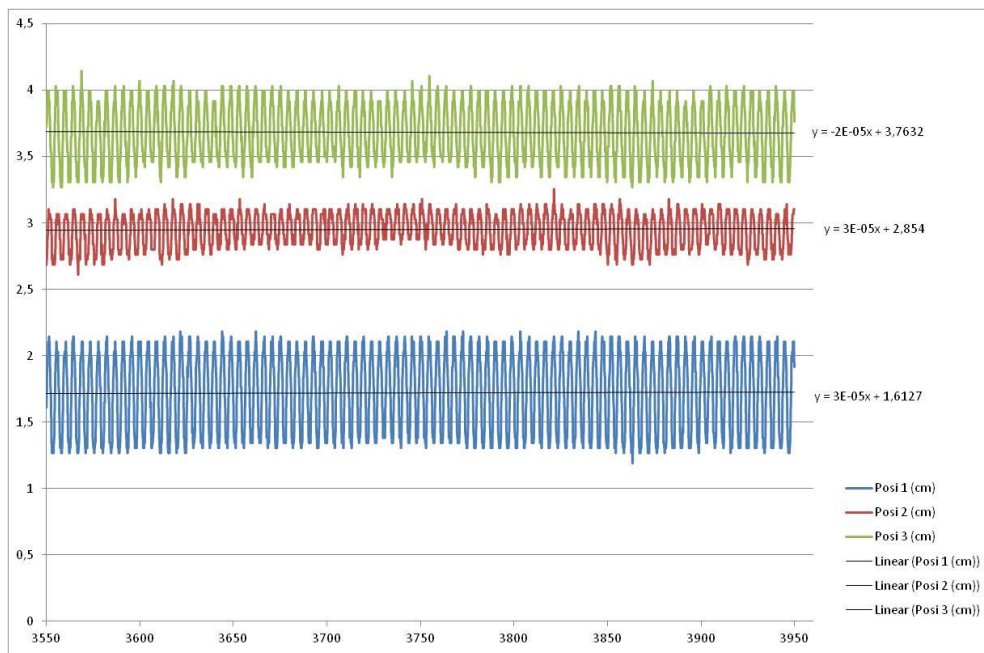
Fig. 55 - Detail from Posiwire showing the rotation while at blade pitch 0 deg

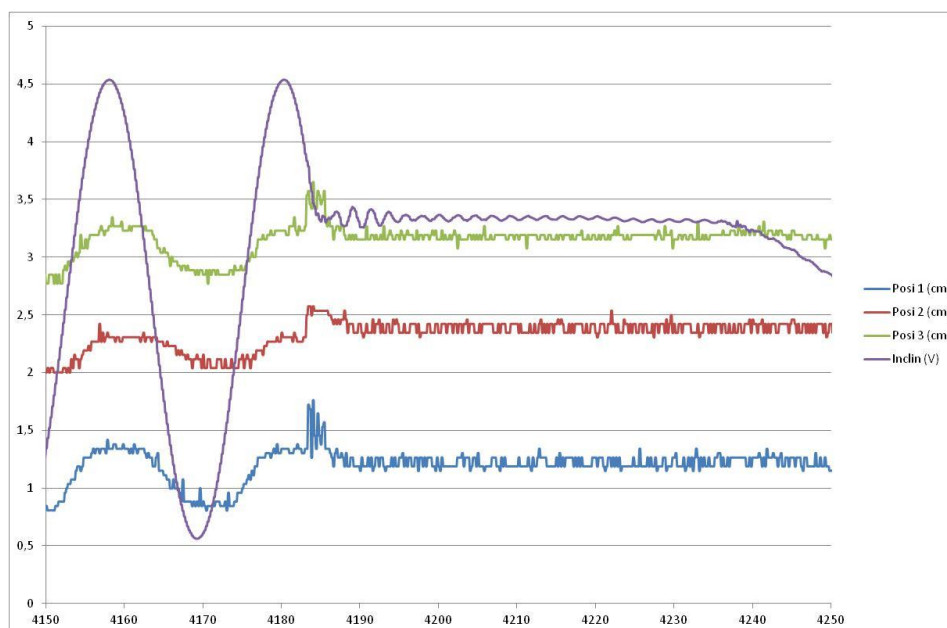
Fig. 56 - Detail from Posiwire showing the “emergency” stop while at blade pitch 30 deg

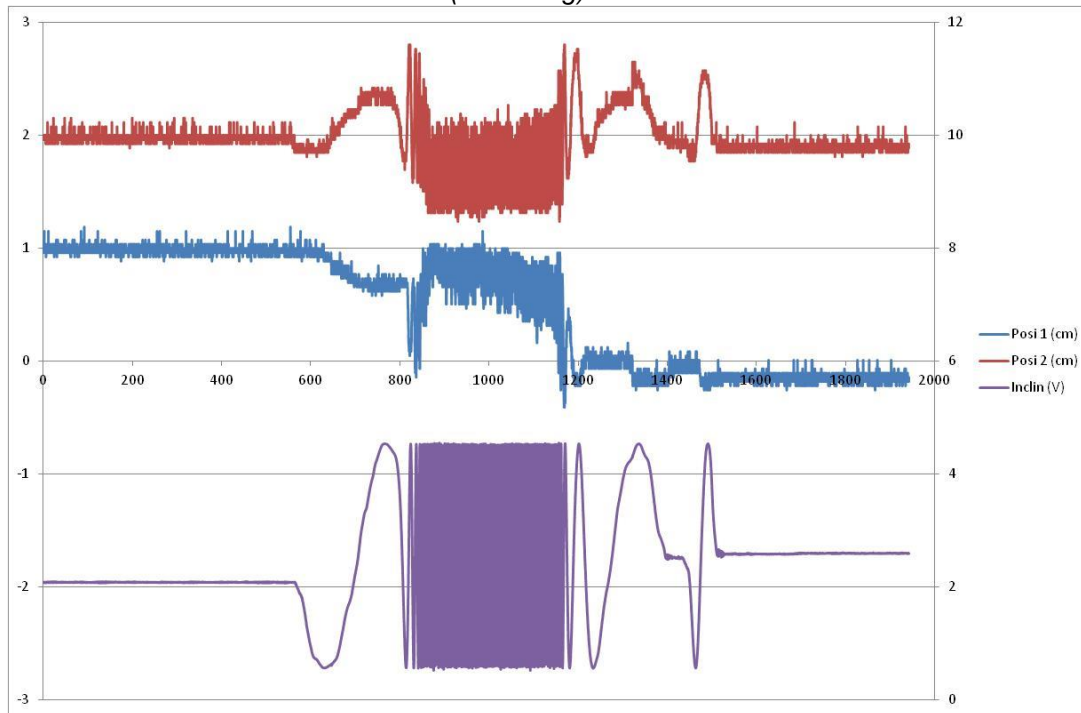
Fig. 57 - Full trace for posiwire beam test 1 (25/Oct)

550s after data acquisition begins the turbine is placed in autorun condition and begins a slow rotation in "idle" condition as the slip ring heats up. At 775s the turbine automatically goes into production condition and runs at between 0 and 3 deg pitch angle. After 1150s the turbine is placed in manual control and the pitch changed to 90 deg at which point the turbine slows. At 1500s the turbine is halted and at 1950s the data acquisition is stopped.

Note also that Posiwire 1 does not return to the original displacement condition (normalised to 1 cm) but ends the measurement around -0.14 cm. And to a lesser degree Posiwire 2 ends the measurement series slightly below its' normalised 2 cm start condition at 1.89 cm.

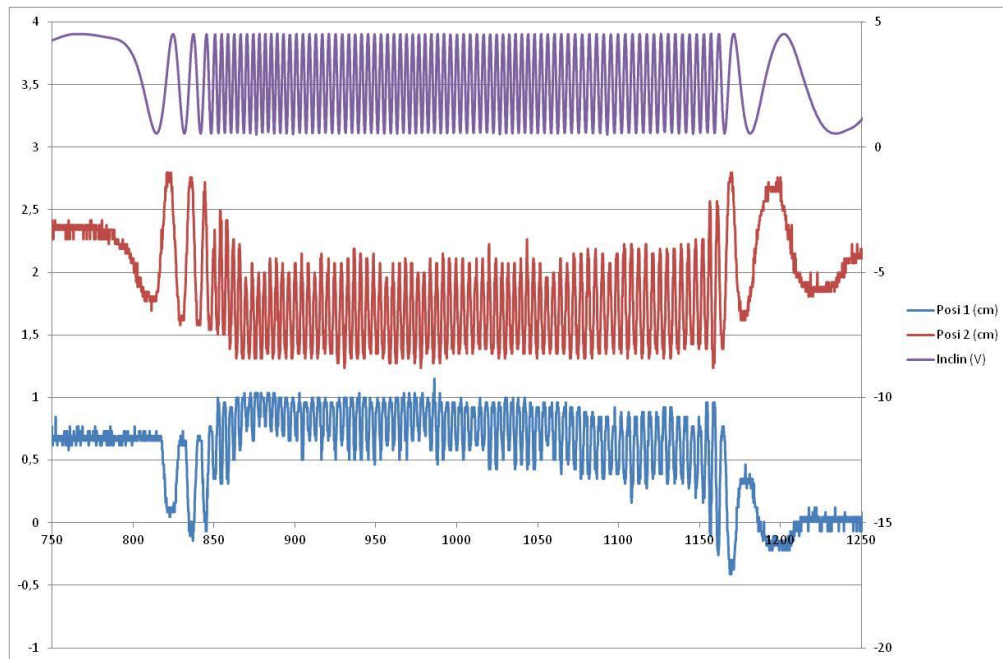
Fig. 58 - Detail from Posiwire beam test 1 showing the main data acquisition period

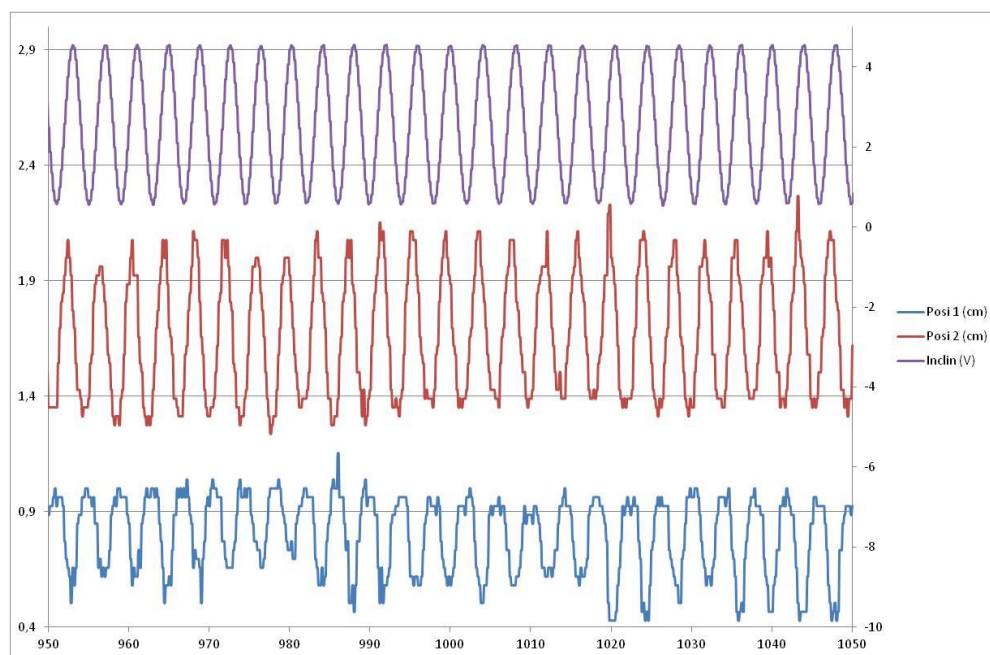
Fig. 59 - Close up detail from Beam test 1 showing the shear behaviour

Beam cross shear distortion during autorun condition average 9mm

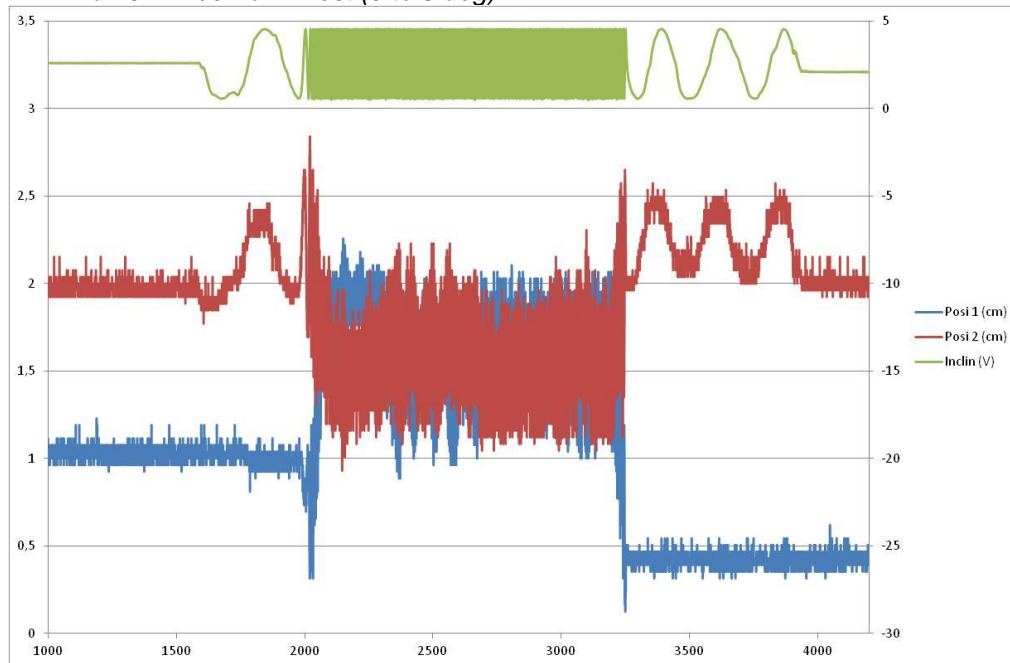
Fig. 60 - Main trace for the Posiwire Beam Test 2 showing the full acquisition period

Around 1575s after data acquisition begins the turbine is placed in autorun condition and begins a slow rotation in “idle” condition as the slip ring heats up. At 2000s seconds the turbine automatically goes into production and accelerates to run at between 0 and 5 deg pitch angle. At 3250s the turbine is placed under manual control again and the pitch changed to 90 deg causing the turbine to slow. At 3950s the turbine is halted. Between 4300 and 5700s the system was dismantled from the box beam while the data acquisition system is still running, the data from this period has been excised from the output graph show here.

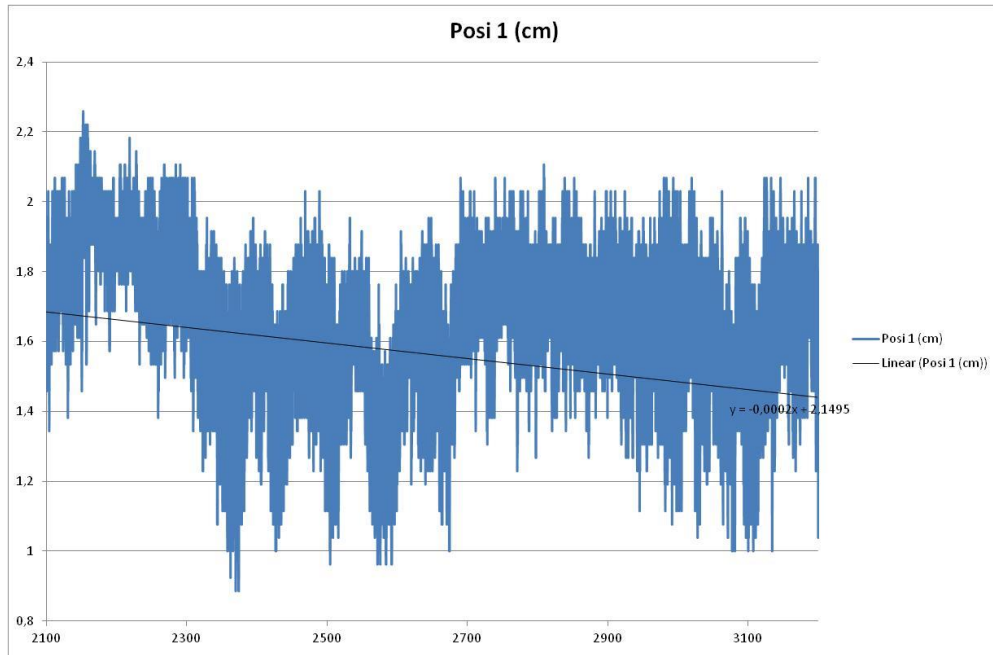
Fig. 61 - Detail from Posiwre Beam Test 2 showing the response of Posiwire 1 only

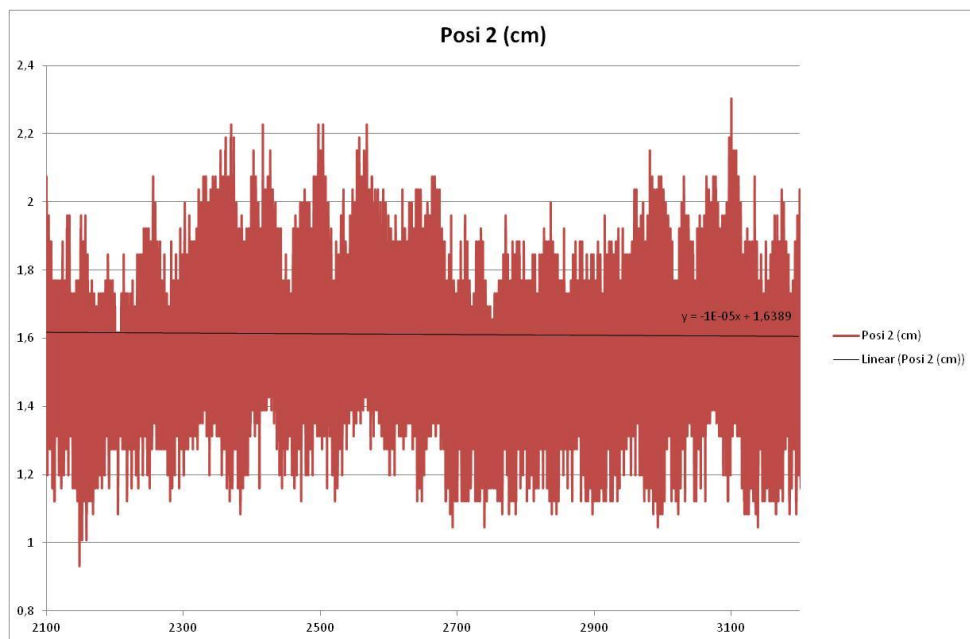
Fig. 62 - Detail from Posiwre Beam Test 2 showing the response of Posiwire 2 only

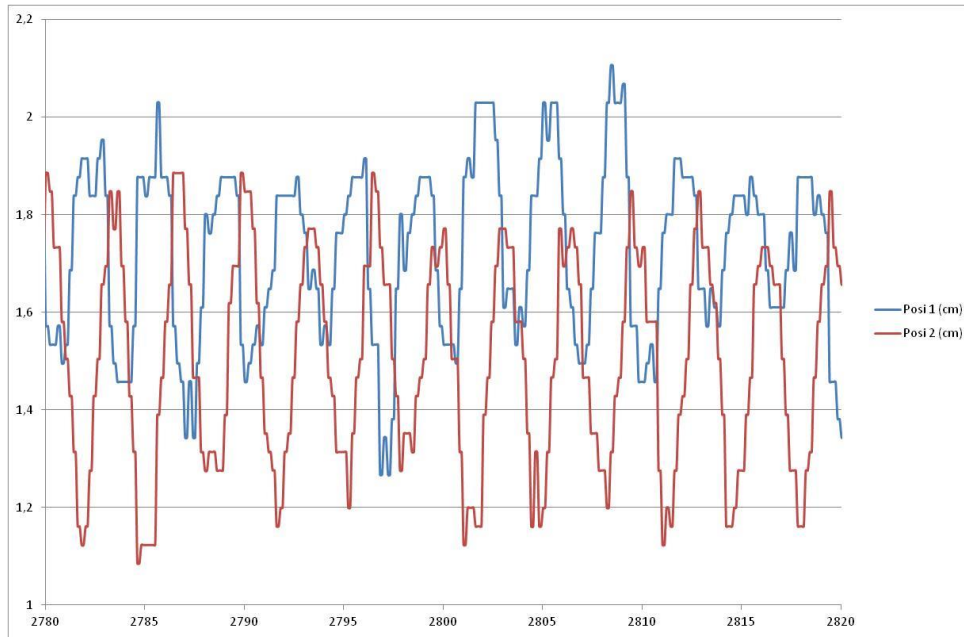
Fig. 63 - Close up detail of the Posiwire output from Beam Test 2
